ELECTRICALLY INDUCED FUEL GAS FIRES

Mark Goodson, David Sneed and Mike Keller

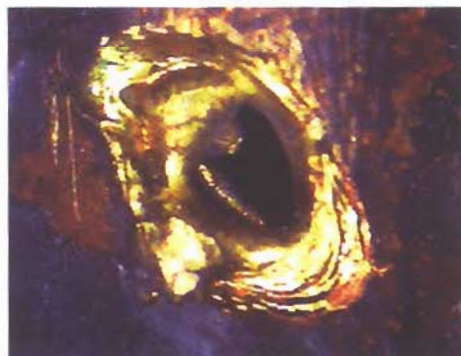
Photo 1. Microscopic view of what was originally believed to be a hacksaw mark

A photomicrograph of the hacksaw mark is shown in Photo 1, while the flared end of the gas line to the water heater is shown in Photo 2. The hacksaw mark is actually a

notch left in the flex line brought about when the line shorted against the metal case of the furnace. The flare fitting on the gas line has been almost completely disintegrated by electrical activity.

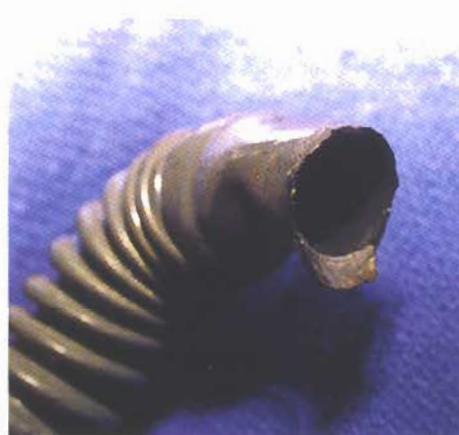
Photo 2. End of flexible gas line with most of the flare having melted due to electrical activity.

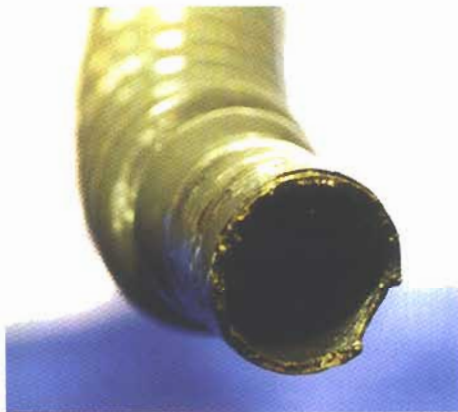
This fire occurred in a heater closet in a residence. The fire was thought to have possible occurred because of some type tampering with the gas lines. The fire originated at a leak in the gas line at the point where the flexible gas line attached to the furnace. Photo 3 shows the end of the flared gas line, it shows almost complete erosion of the flare.

Photo 3. End of gas line with flare being destroyed by electrical activity.

In the enclosed Photo 3, one can see that much of the polymer coating is still present

on the gas line, and yet at the flare the brass has focal melting present. Testing of the polymer coating shows that it decomposes at temperatures of between 400 and 500 degrees F; brass requires temperatures of about 1700 degrees F before it will melt. Clearly, this type of damage cannot be from flame impingement. It is also noted that the brass flare is well protected from flame by the brass nut that definite lines of demarcation. In a distance of about 1/8", the heating of the arc will cause a transition to be made from melted brass to non-melted brass, and from no polymer coating (completely pyrolyzed) to an intact polymer coating. This rapid transition from extremely damaged (melted) brass to undamaged polymer is a very typical of an electric arc. Were the thermal damage caused by a flame, there would have been greater areas of heat stressing of the polymer coating.

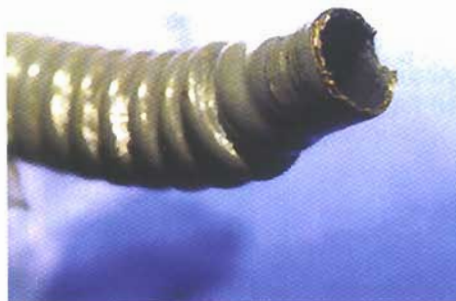
Photo 4. Side view of gal line in Photo 3, with the polymer coating still relatively intact because of protection provided by the brass nut.
