ELECTRICALLY INDUCED FUEL GAS FIRES

Mark Goodson, David Sneed and Mike Keller

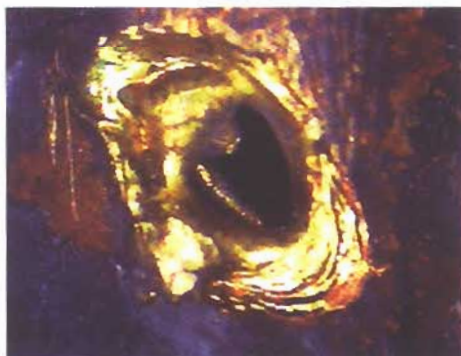
Photo 1. Microscopic view of what was originally believed to be a hacksaw mark

A photomicrograph of the hacksaw mark is shown in Photo 1, while the flared end of the gas line to the water heater is shown in Photo 2. The hacksaw mark is actually a

notch left in the flex line brought about when the line shorted against the metal case of the furnace. The flare fitting on the gas line has been almost completely disintegrated by electrical activity.

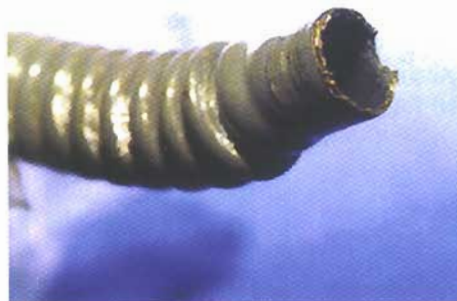
Photo 4. Side view of gal line in Photo 3, with the polymer coating still relatively intact because of protection provided by the brass nut.
